# Truck Driver Jostling Injury Investigation at Container Port Expert Article

## Truck Driver Jostling Injury Expert Investigation

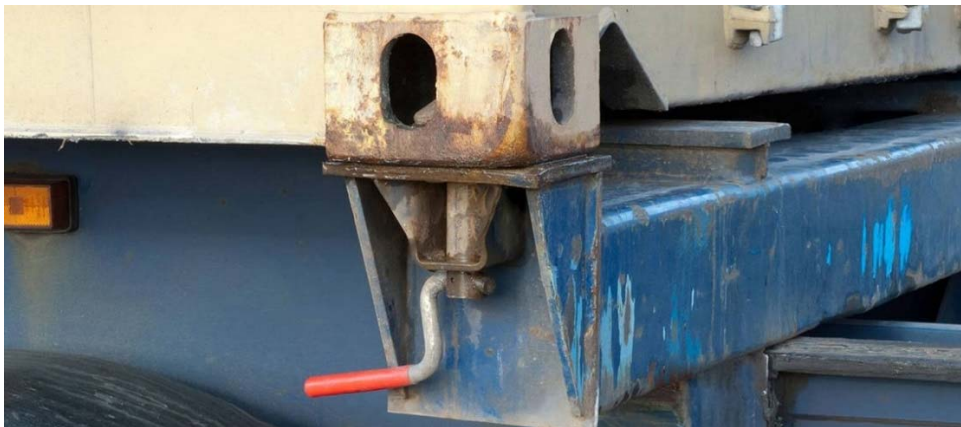
Corner Twist Lock Device, Photo Courtesy Container Sales Group

Shipping container (aka “Cans or Boxes”) Twist Locks secure boxes to the trailer during highway transport and in other modes. Container twist locks work by a fastening device at each of the four (4) structural corner posts of the container, and then secures it to the chassis frame or trailer.

**DANGER:** Locked, bound, or obstructed Twist Lock Devices are a significant safety hazard

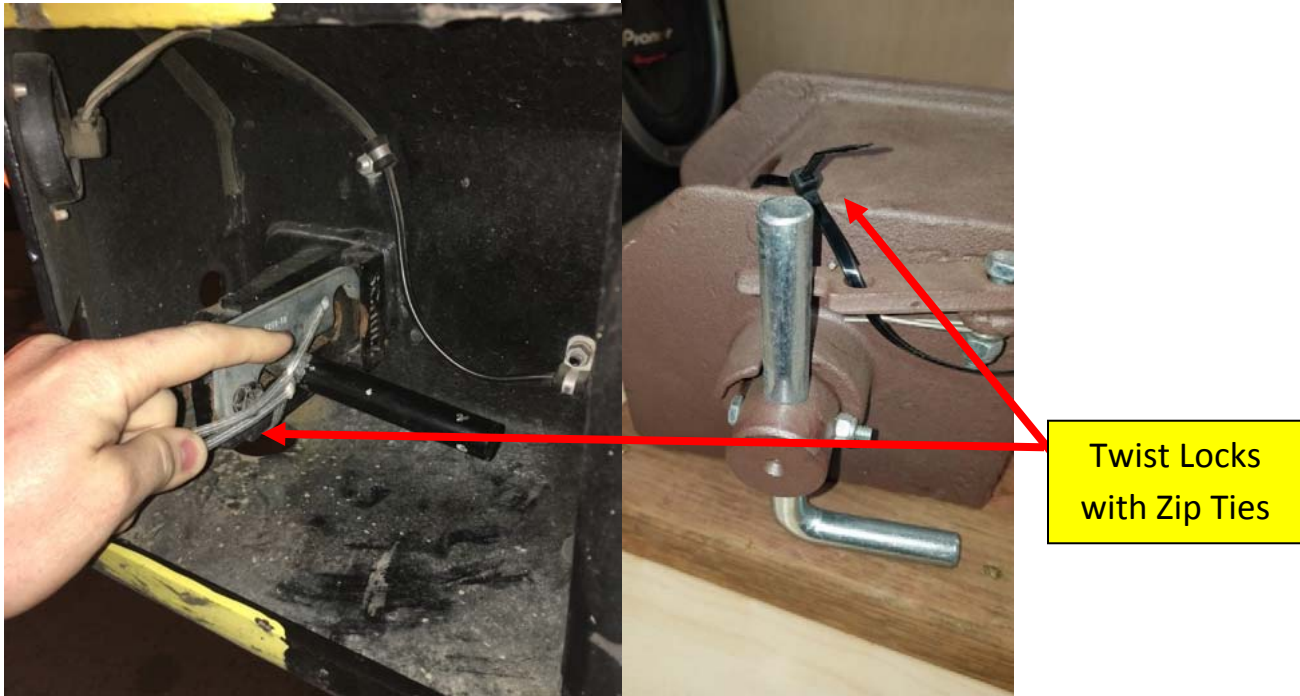
Drivers frequently attach nylon zip cable ties, wire or other forms of securement to prevent displacement of a shipping container during transport.

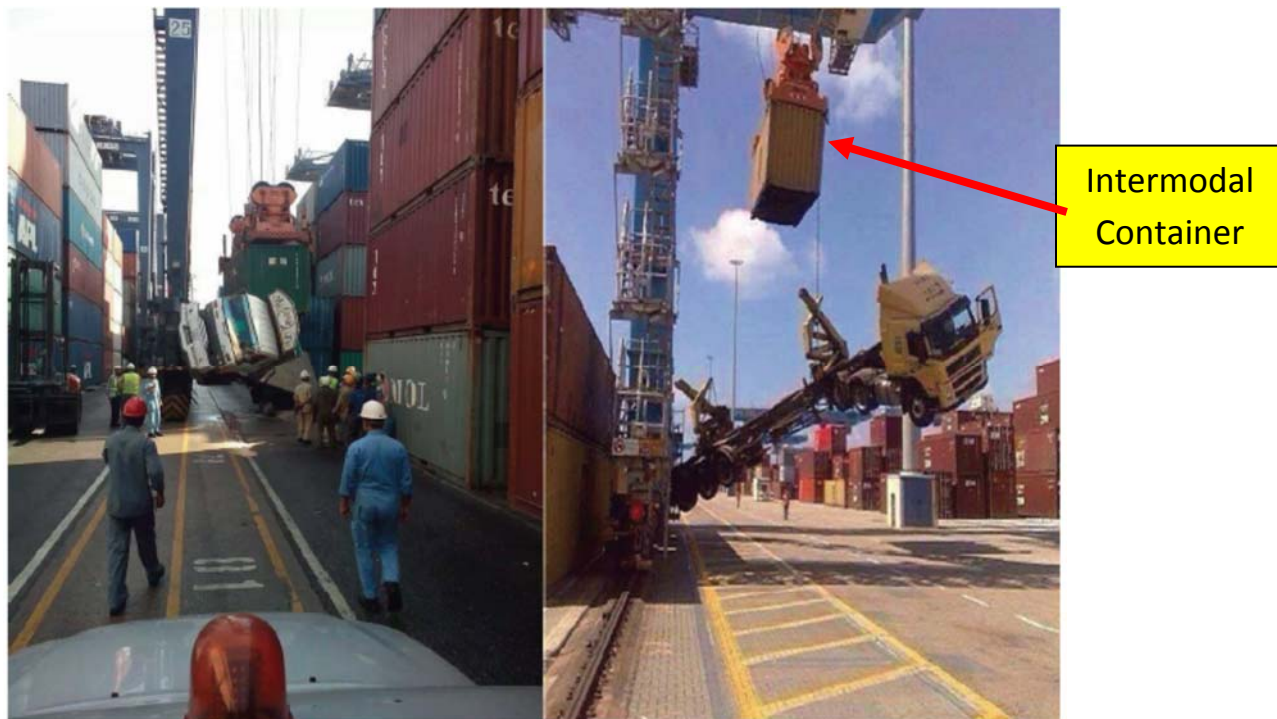
While sitting in the cab at the port during the onloading procedure, drivers need to be aware that their equipment (semi-tractor trailer) can be inadvertently hoisted aloft together with the container by the crane or PIT.

Photos Courtesy ILA-USMX OSH Circulars 2017

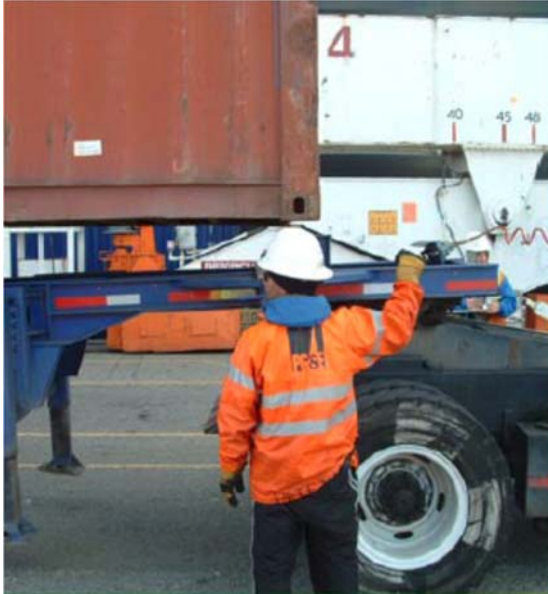
In order to preclude hoisting injury to truck drivers a protective rule for equipment and crane operators requires them to “Float The Load.” This is to ensure clear separation of the container from the (tractor’s) chassis or bomb cart, before lifting the unit off the chassis.

Floating the Load, Photo Courtesy Longshore Safety Tip (ILWU/PMA 2008)

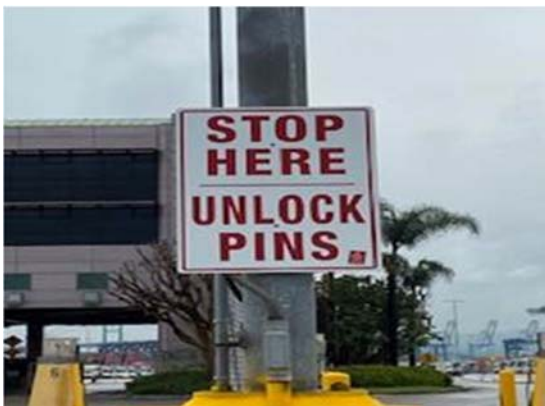
In the summer of 2022, a truck driver arrived at the maritime shipping port to deliver an intermodal container. As the truck driver lined up in the terminal queue with other trucks and trailers, a posted sign instructs drivers to “Stop Here Unlock Pins.”

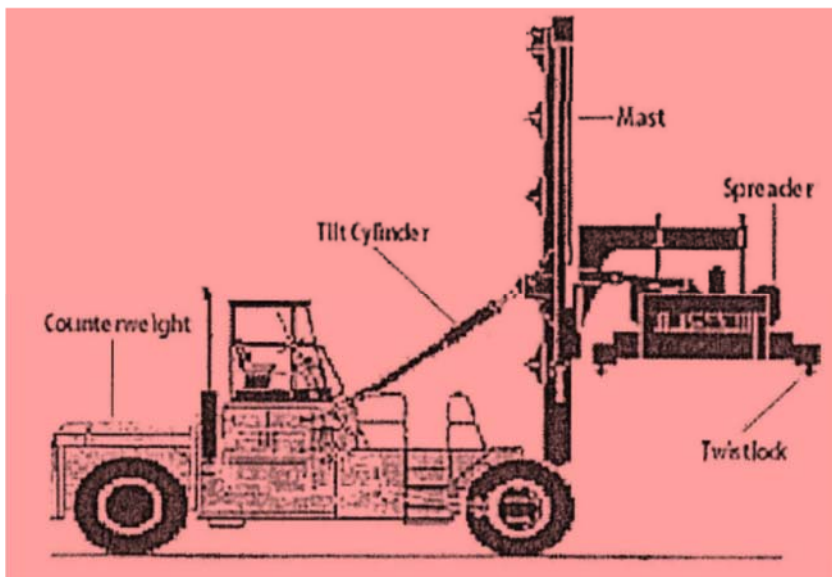
Unpinning of the container is both a mechanical and safety requirement in order to expedite safe unloading by the terminal equipment operators. The subject container in this incident was 40 feet long and positioned on a chassis, a special trailer designed to carry intermodal shipping containers. A heavy duty Top Handler was involved in the incident, which is a type of powered industrial truck (PIT) with a forward reaching mast and spreader system, designed to hoist and stack heavy shipping containers on and off trucks.

Top Handler, Graphic Courtesy Pacific Maritime Association (PMA)

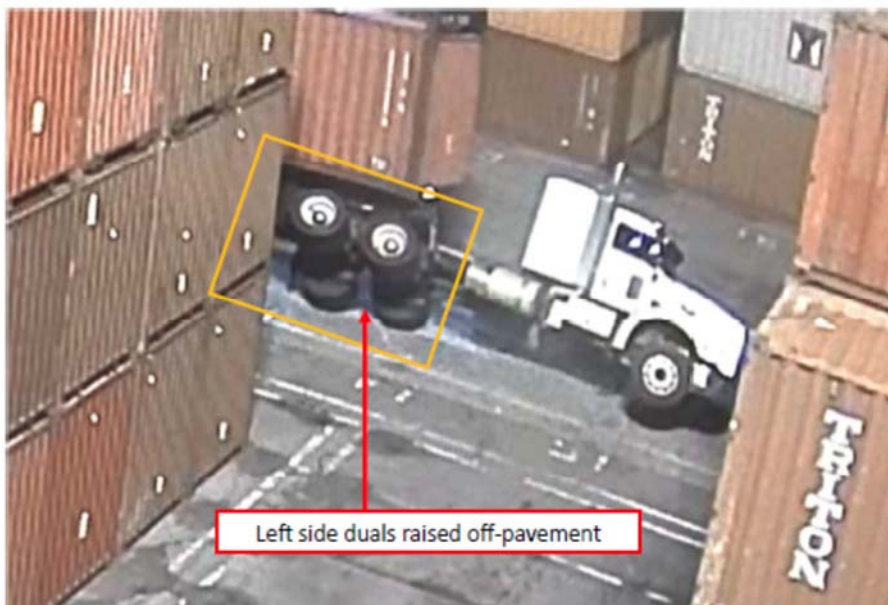
Investigation revealed that the driver failed to identify and remove a nylon zip tie from one of the twist locks. In addition, the victim's fall and associated injuries were directly related to his failure to use a seat belt, and to wear a hard hat.

Analysis of an onsite video clip of the incident discovered that the Top Handler operator failed to float the load, or to verify safe separation of the container from tractor-trailer (chassis). Due to operator negligence the load was abruptly hoisted raising the entire unit off the ground, then forcefully returned to the pavement, seriously injuring the truck driver. The operator's unsafe action was a violation of established safety rules, and deemed to be the principal cause of injury.

Following a thorough forensic investigation, our experts concluded that the PIT operator failed to meet industry standards by performing an unsafe act and failing to follow established safety rules. The truck driver also neglected to identify an obstructed twist lock, and to remove a zip tie. He also failed to wear approved head protection (PPE), and to use his seat belt.

Consequentially, the primary cause of injury was the Top Handler's unsafe act, which violated applicable standards and established trade safety rules. Responsibility for inspection of the chassis and container upon entry was the domain of the truck driver, who failed to take corrective action to remove a physical obstruction from a twist lock devise.

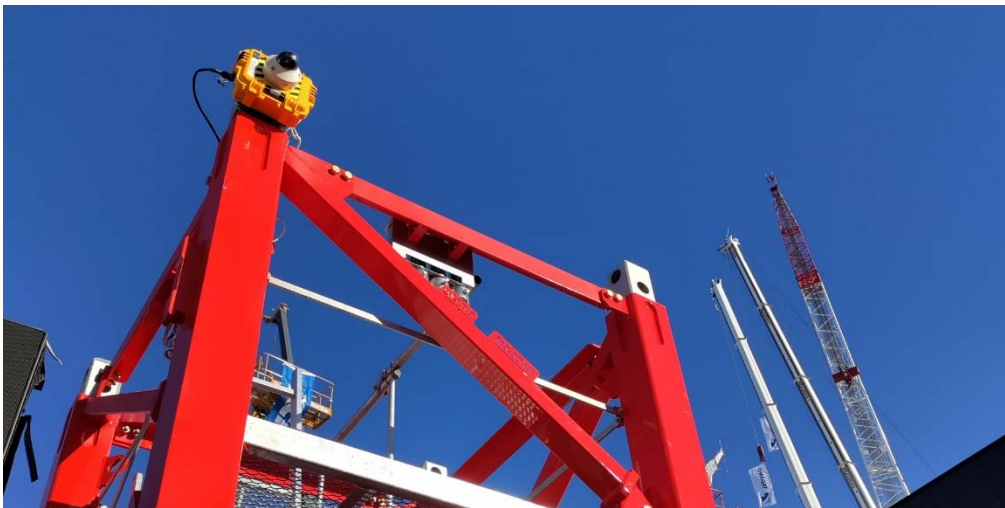
In review of post incident video content from onsite security cameras, prior to hoisting, the PIT operator did not check the chassis and its twist locks. Additionally, there were no external wireless or digital cameras mounted on the Top Handler mast or spreader. Cameras can be attached to the elevating mast or spreader mechanism to assist operators in identifying ground personnel, obstructions, oncoming vehicles and more.

Frame mounted camera on equipment (Photo Courtesy HoistCam by Netarus)
